**Crack initiation and propagation paths in small diameter FSW 6082-T6 aluminium tubes under fatigue loading**

Frattura ed Integrità Strutturale

## Crack initiation and propagation paths in small diameter FSW 6082-T6 aluminium tubes under fatigue loading

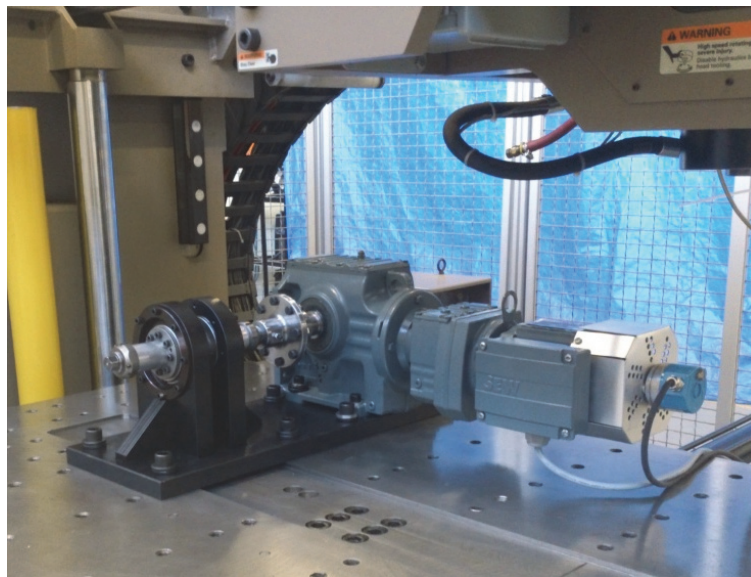
Figure 1: Illustration of a tube specimen in position ready to be welded.

Fig. 1 shows details of the clamping system and the various components are identified as given below:

1. Precision locknut
2. Fenlock cone clamp
3. Flange connecting motor to tube drive shaft
4. Support bearings

5. Tube to shaft coupling
6. Motor keyway lock bolt

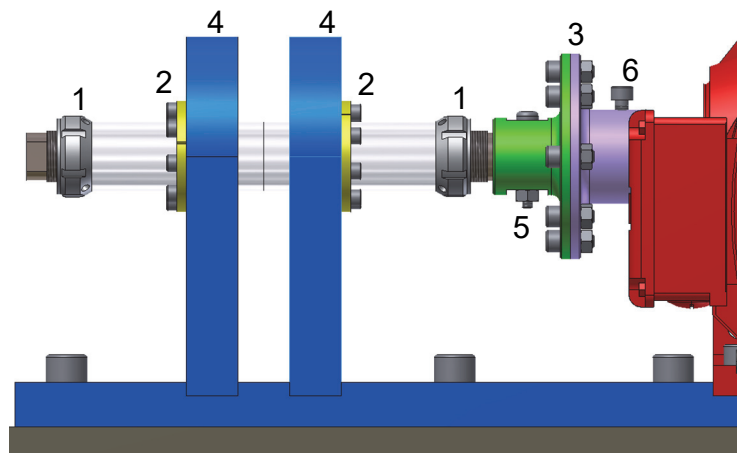
Figure 2: Schematic diagram showing the various components in the tube clamping system.

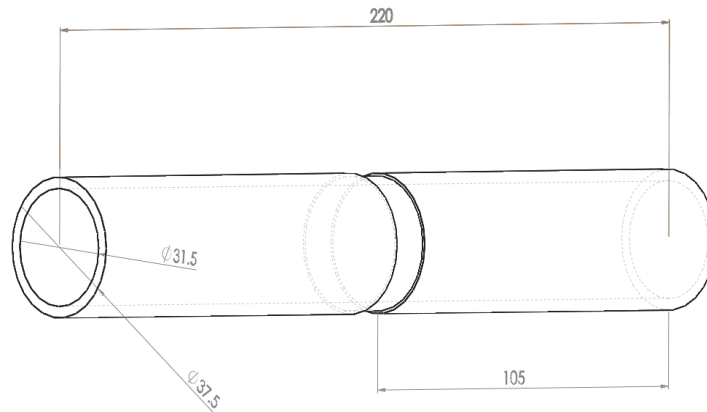
The fatigue specimens consisted of two 110 mm lengths of 6082-T6 aluminium tubes joined by friction stir welding, as shown in Fig. 3.

Figure 3: Geometry of the welded tube specimens. All measurements are given in mm.

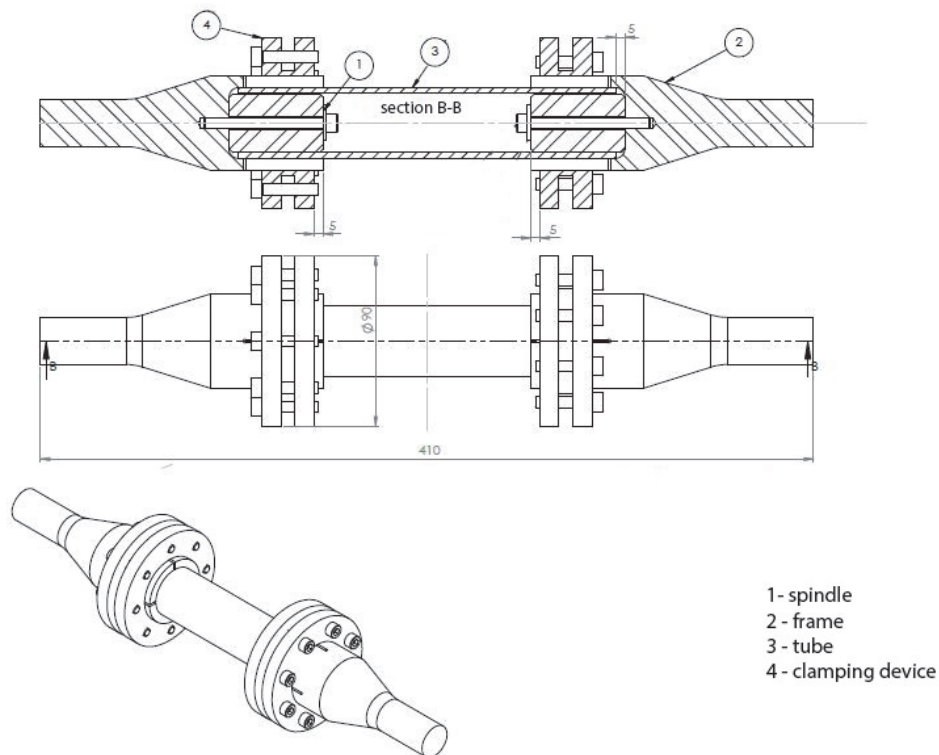
To grip the specimens in the 250 kN MTS fatigue testing machine used in this work, a pair of tube gripping fixtures were manufactured from high strength steel (see Fig. 3) that were connected to the tube by commercial clamping devices with an internal insert in the tubes to prevent deformation induced during clamping of the grips.

Figure 4: Diagram showing the tube clamping fixtures in place on a fatigue specimen.

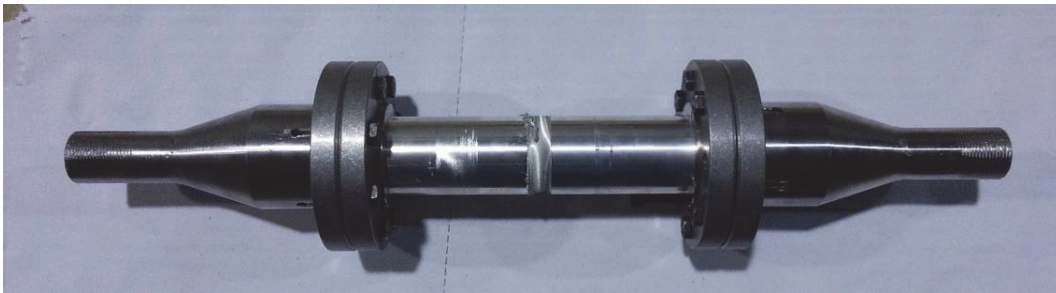
Figure 5: Complete assembled fatigue specimen and clamping fixtures.

Fig. 5 shows complete assembled fatigue specimen and clamping fixtures, while Fig. 6 shows the various parts of a single clamping fixture.

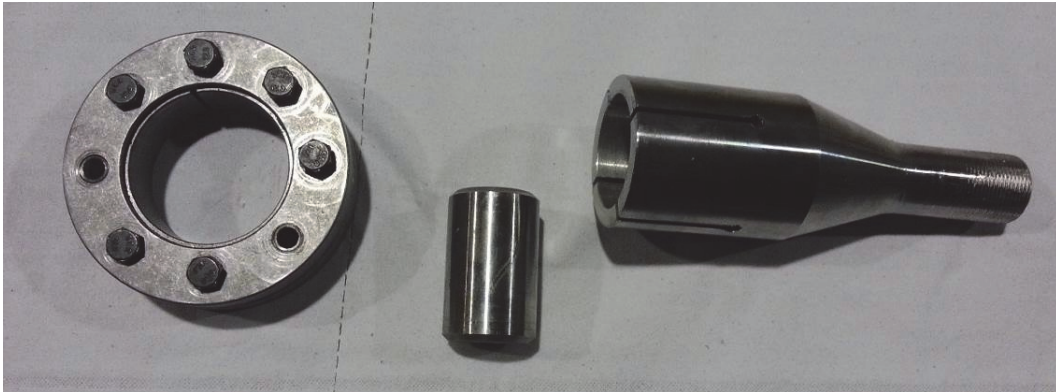
Figure 6: The various parts of a single tube end clamping fixture.

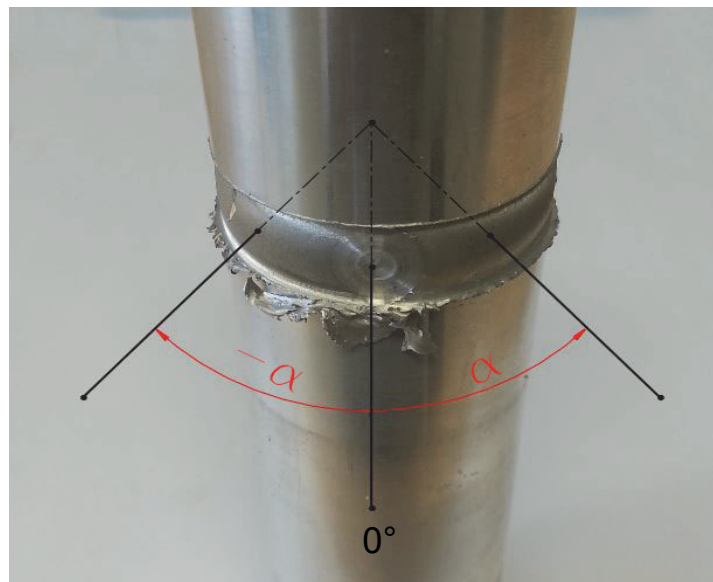
Crack initiation sites are defined in terms of their angular position relative to the end point of the weld, given as  $0^\circ$  in Fig. 7 where the advancing side of the weld is towards the top in the figure, and the retreating side is towards the bottom.

Figure 7: Coordinate system used to define the crack initiation sites.

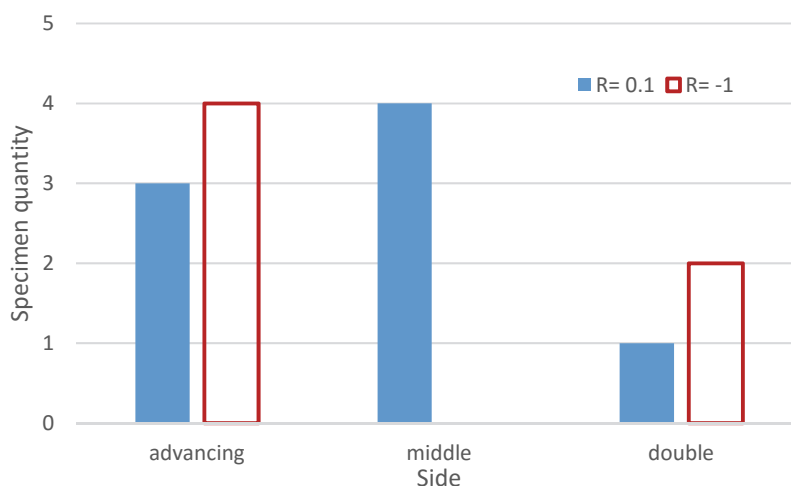
Figure 8: Frequency of crack initiation by location.

Crack initiation was located in the advancing side of the weld in almost half of the specimens, usually closely associated with the slight undercut at the edge of the weld zone. Tab. 3 gives the location of crack initiation for all of the specimens where cracking was observed. In the two specimens that were left intact (W117: 709,775 cycles and W121: 476,829 cycles) cracking had initiated along the middle plane of the weld zone and one specimen fractured through the middle of the weld (W118: 1,247,627 cycles). The data is summarised in the bar chart shown in Fig. 8.

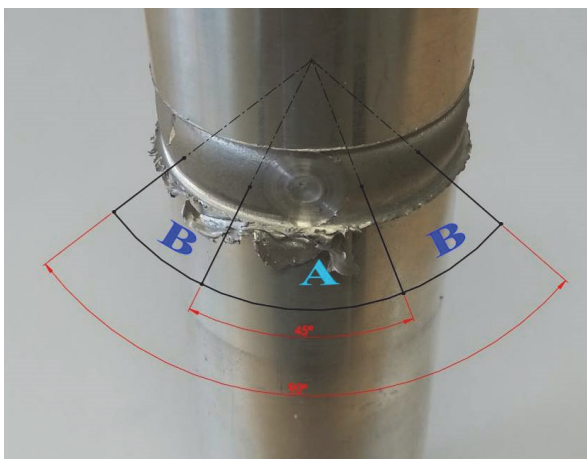
To further aid in identifying the various crack initiation locations relative to the end point of the weld, three zones were defined around the nugget, as seen in Fig. 9, while Fig. 10 summarises crack initiation data in terms of their frequency of occurrence in the three zones:

A: within a range of  $45^\circ$  around the centre of the stop position of the weld

B: within a range of  $22.5^\circ$  outside zone A in both directions ( $\alpha^+$  and  $\alpha^-$ )

C: the remainder of the weld circumference

Figure 9: Definition of the 3 zones around the weld circumference.

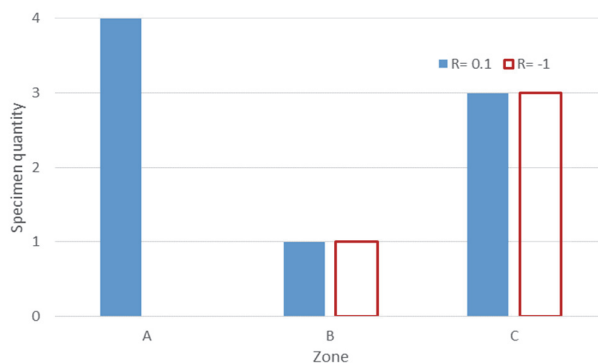
Figure 10: Number of crack initiation sites in each zone.

Fig. 10 gives a bar chart summarising the frequency of crack initiation as in each weld zone, while Figs. 11-13 respectively give illustrative examples of the crack paths associated with crack initiation at the advancing side undercut, the middle of the weld zone, and double crack initiation.

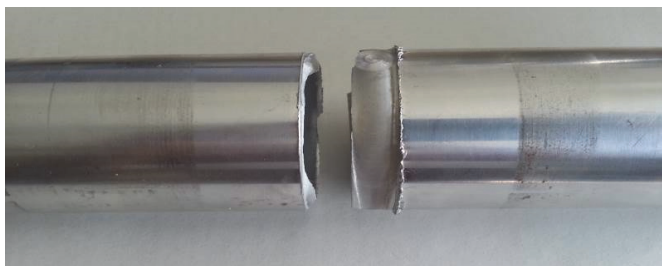
Figure 11: Typical advancing side crack path (W114).

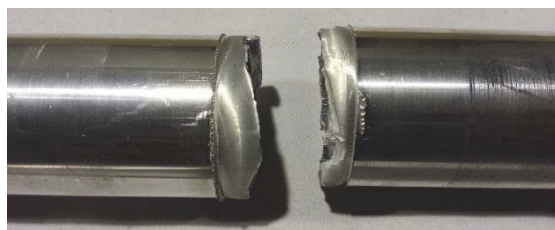
Figure 12: Crack path associated with crack initiation in the middle of the weld zone (W130).

Fatigue crack paths were clearly influenced by crack initiation sites and could therefore exhibit crack path deviation across the weld zone, as is clearly shown in Fig. 12 for the case of initiation sites at the undercut at both edges of the weld; the crack has grown faster along the advancing side and then moved across to the retreating side. Where the crack path remained in the middle of the weld zone, this appeared to be associated with the presence of porosity defects in the weld. [7]. Crack initiation in the middle of the weld is uncommon and the metallurgical reasons for this behaviour are still being investigated. Figures 14 and 15 give SEM images of typical initiation sites in specimens W111 (19,763 cycles) and W121 (476,829). It is clear that in both cases initiation is associated with the small local stress concentrations due to the tool shoulder marks arising from the tool advance during a single tool rotation

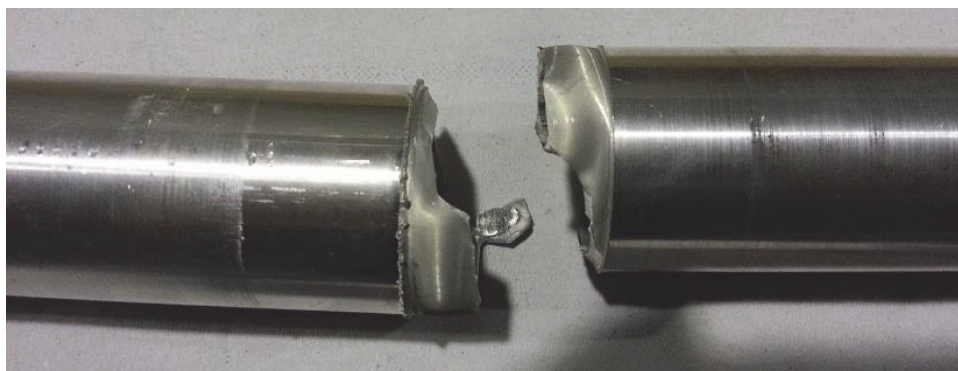
Figure 13: Crack path associated with double crack initiation sites (W124).

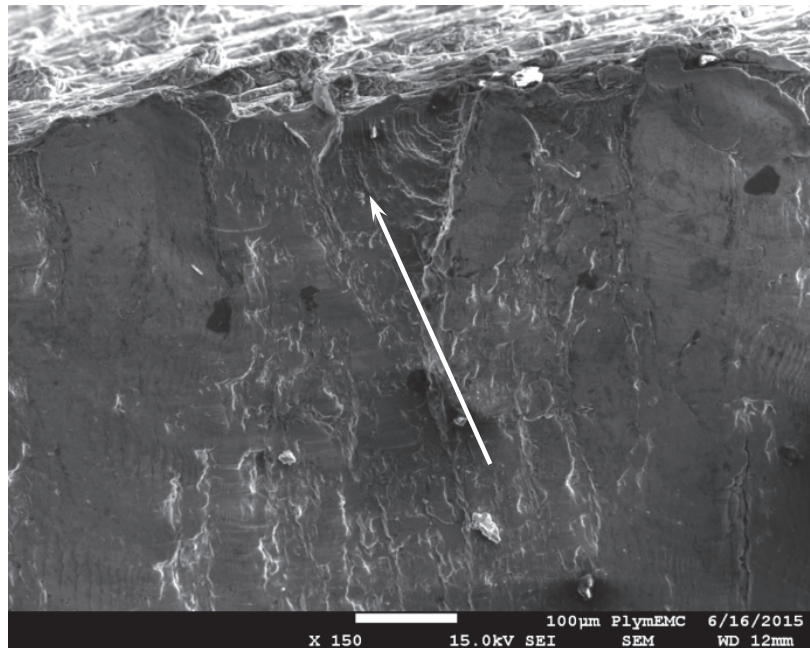
Figure 14: Crack initiation site in specimens W111 (marked with arrow).

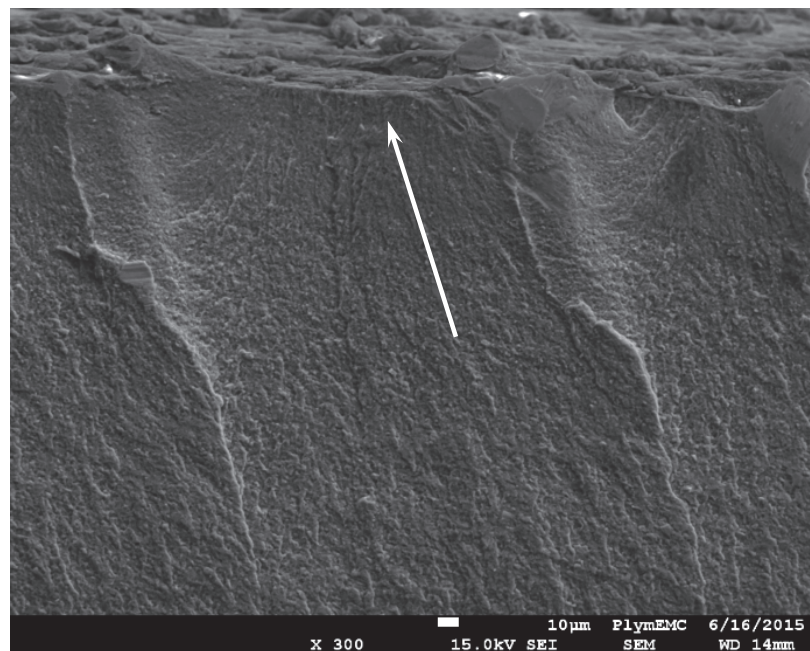
Figure 15: Crack initiation site in specimen W121 (marked with arrow).

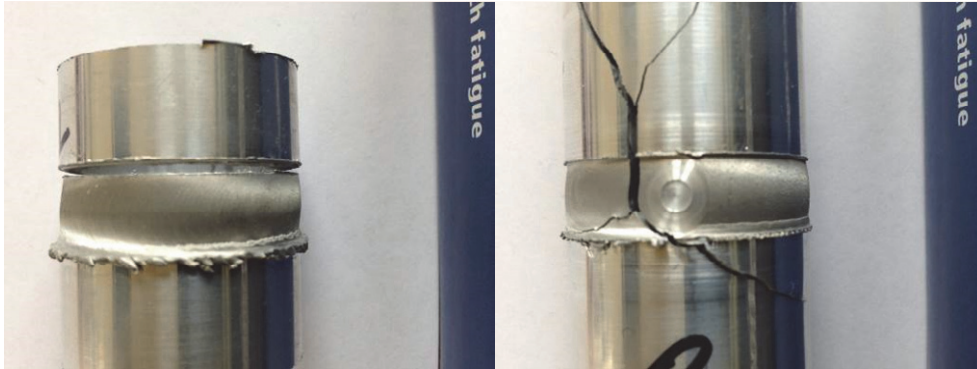
**F**igs. 16 and 17 show typical crack paths for specimens tested in fatigue under pure torsion loading.

Figure 16: Example of torsion test, T2 and T6 ( $R=-1$ , stress amplitude = 42 MPa).

It is clear that the crack paths are considerably more complex under torsional loading and that some specimens do not show the classic  $45^\circ$  torsional crack propagation; for example, T2 resembles a pure tensile fracture. Others specimens present multiple crack propagation paths (e.g. T6) and T16. Further details of the torsion tests performed can be obtained in reference [6].

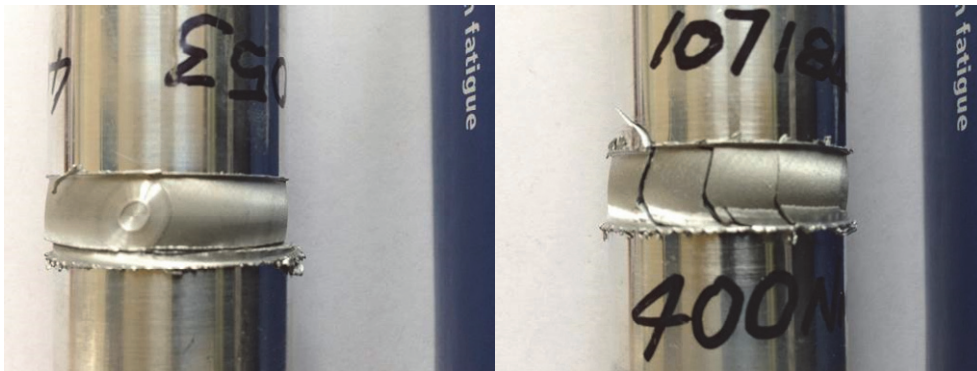
Figure 17: Example of torsion test, T11 ( $R=-1$ , stress amplitude = 66 MPa) and T16 ( $R=0$ , stress amplitude = 33 MPa).
